Dec. 2009, Country Road performs **special project** work on dilapidated balcony that was structurally compromised by age and water damage to wood supports.

Balcony Reconstruction Project. Photos to left and right show partial new rafter installs, first layer of steel reinforcing brackets, and replacement of vertical wall studs both sides.

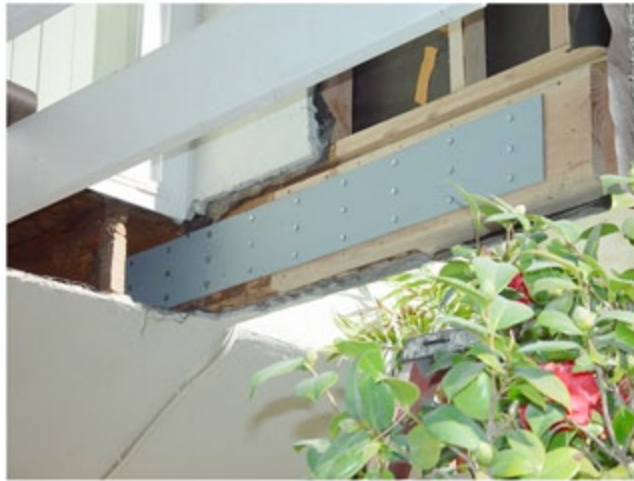
Photos above to left and right show 2nd layer of steel reinforcing brackets on double rafter. The 2nd bracket was five ft. in length. All steel and wood was primed on all six sides PRIOR to install, except for wood encased within the stucco structure, which is protected by moisture barrier paper.

This balcony was the worst we have encountered during the past 23 years.

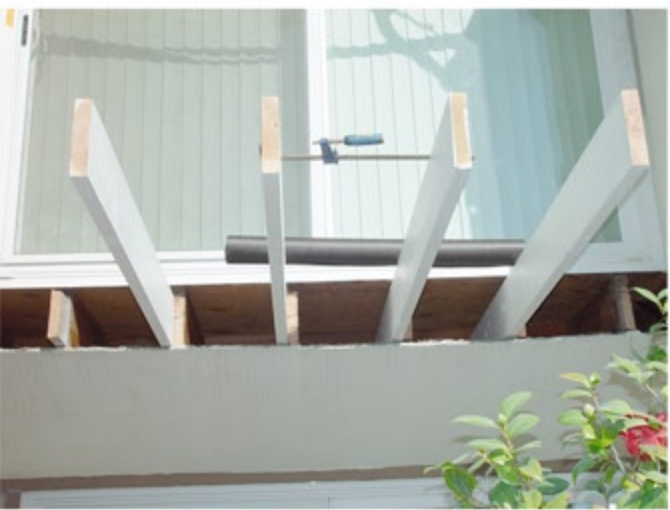
Photo above left shows most but not all new rafters installed, and before fire blocking was installed between, followed by moisture paper, metal lath, and three separate coats of stucco.

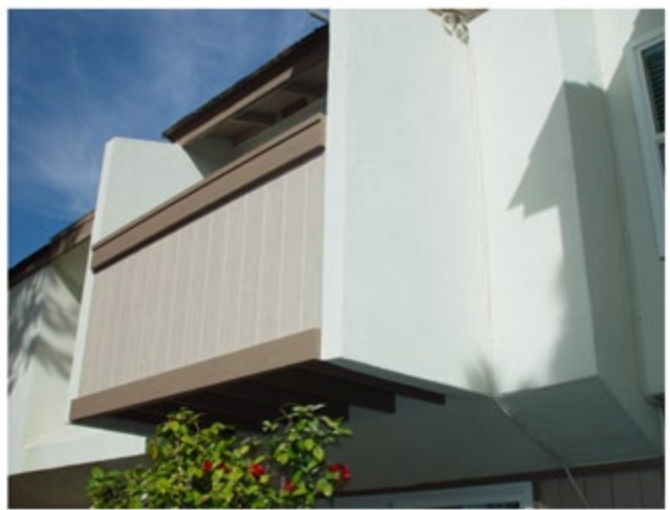
Completed job, Owner reports he was very pleased with results.
